SERVICE BULLETIN

Number 20141121

Title: Solution for water dripping from Evaporator region.

Models effected: XX ASR680, XX ASR1370, XX ASR2055

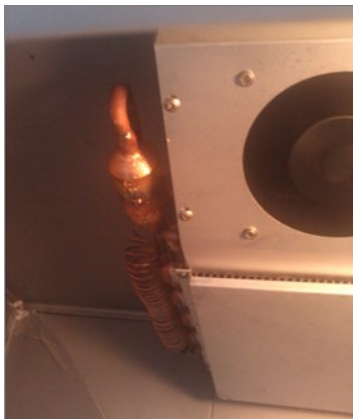
Reason: Earlier designs of the drip trays fitted did not cover the accumulator, suction line or return bends. Under high humidity and frequent door opening conditions, condensation forms on the accumulator and drips onto the Evaporator-Cover which is not part of the drainage system.

Accumulator Sitting forward of evaporator. Drip-tray only below finned area of evaporator.

1. Remove Evaporator-Cover and Drip-Tray.
2. Cover accumulator with Aeroflex. Securing with cable ties.
3. Use 2 x 8 gauge self tapping screws to attached the new Drip-Tray to the Evaporator-Cover.
4. Re-install Evaporator –Cover.

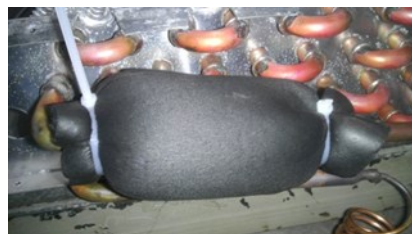
Accumulator covered with Aeroflex

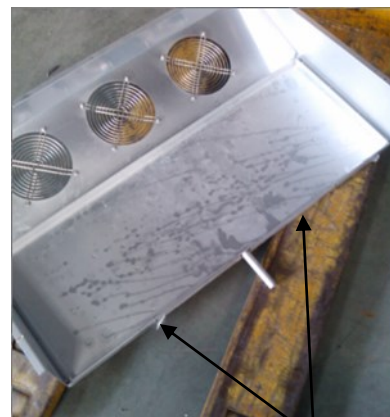
New larger drip-tray screwed to Evaporator-Cover
