SERVICE BULLETIN

Number 20160708(2)

Title: Replacement S/S handle for full length handle.

Models effected: ME-S6, ME-S7, ME-D10 and ME-T16.

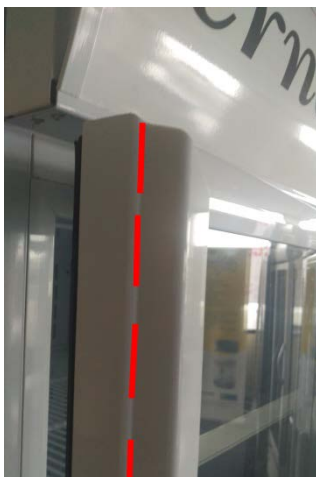
Use saw to cut off faulty handle

1. Use saw to remove handle portion from Door frame.
2. Remove plastic protection from S/S handle
3. Hold Handle in place (3mm from back edge of door frame)
4. Drill and attach handle. Note: top and bottom Screws drill into Aluminium corner Stakes. Centre crew drill into plastic
5. Remove Handle clean and apply Araldite.
6. Reattach handle

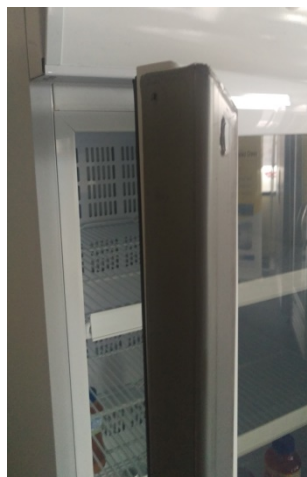
Replacement Handle Position approx. 3mm from back of frame

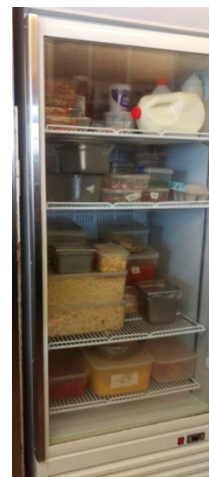
Handle Fitted
